Manhole Inspection Summary

Manhole # S15EE_008MH

Insp Date: **7/27/09 10:13 AM**

Location Address: **1238 BRADDISH AVE**

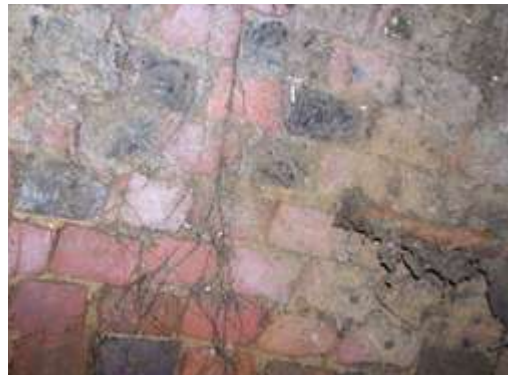
Defect 2

Condition: ☐ Sound ☐ Cracked ☒ **Root Intrusion** ☐ Loose Brick ☐ Deteriorated

Infiltration: ☐ None ☐ Joint ☐ Cracks ☐ Mortar ☒ **Roots** ☐ Wall

ROOT INFILTRATION BARREL # 2

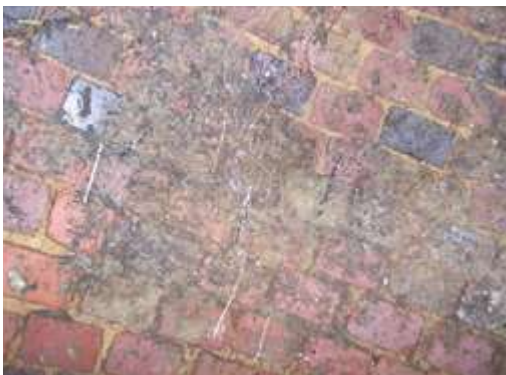
Defect 1

ROOT INFILTRATION - BARREL

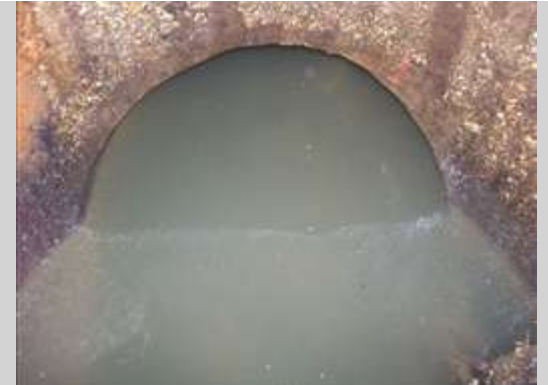
12 O'Clock Outflow

39 in. Circular Gravity Sewer
Pipe Out @ 12 O'Clock

Pipe Height: (in.) Direct
Pipe Material: **Clay** ☐ Pipe Lined
Invert Depth: **32.08** (ft.) Flow Characteristics: **Slow**
Deposits: ☒ None ☐ Mud ☐ Sludge ☐ Debris ☐ Grease
Silt Depth: (in.) Deposits Extent:
Infiltration: **None** Pipe Seal Cond: **Sound**

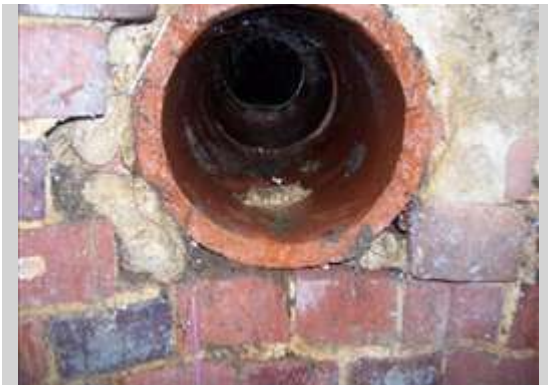
4 O'Clock Inflow

ROOT INFILTRATION BARREL # 2

Pipe Height: (in.) Direct
Pipe Material: **Clay** ☐ Pipe Lined
Invert Depth: **12.14** (ft.) Flow Characteristics: **None**
Deposits: ☒ None ☐ Mud ☐ Sludge ☐ Debris ☐ Grease
Silt Depth: (in.) Deposits Extent:
Infiltration: **None** Pipe Seal Cond: **Roots**

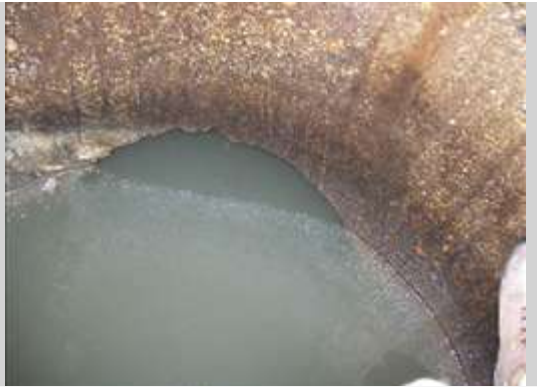
6 O'Clock Inflow

33 in. Circular Gravity Sewer
Pipe In @ 6 O'Clock

Infiltration: **None** Pipe Seal Cond: **Sound**
